## Potterhanworth Road pavilion guttering

Report by: Elaine Atkin

Date: 12/08/26

Report to: Parish Council 09/2026

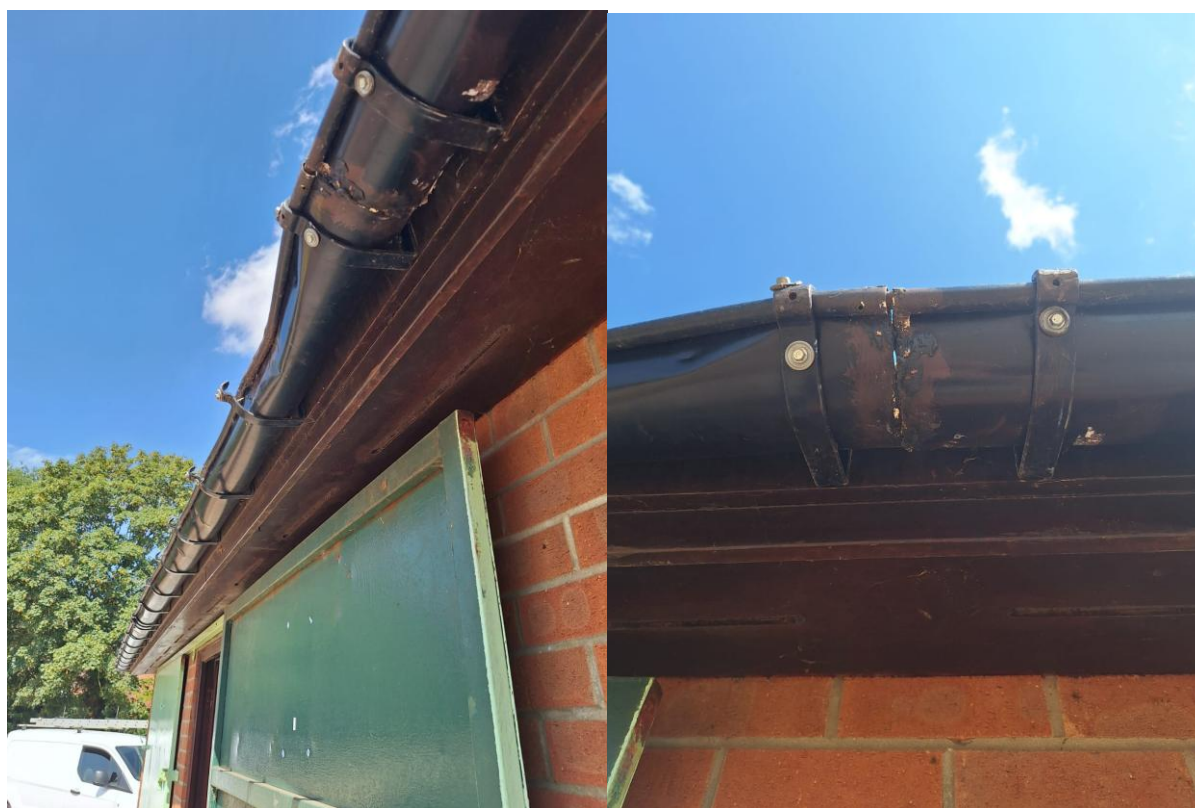
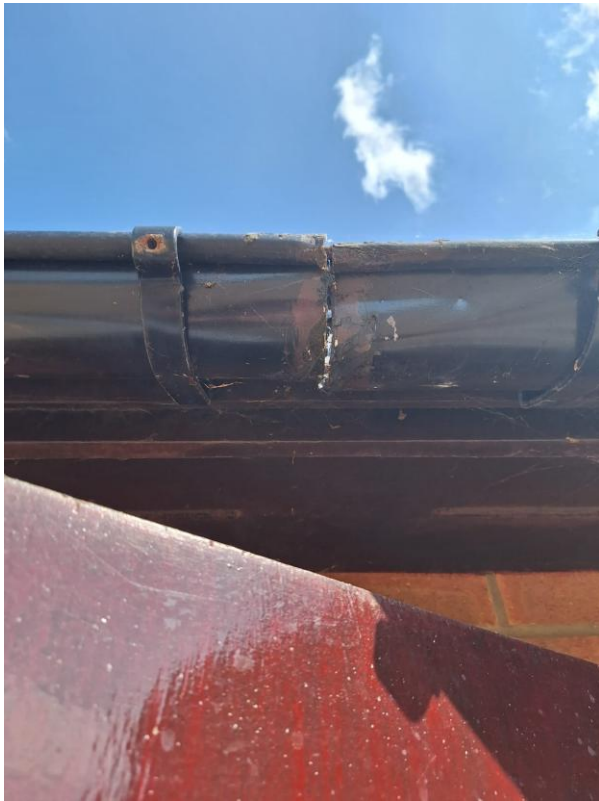
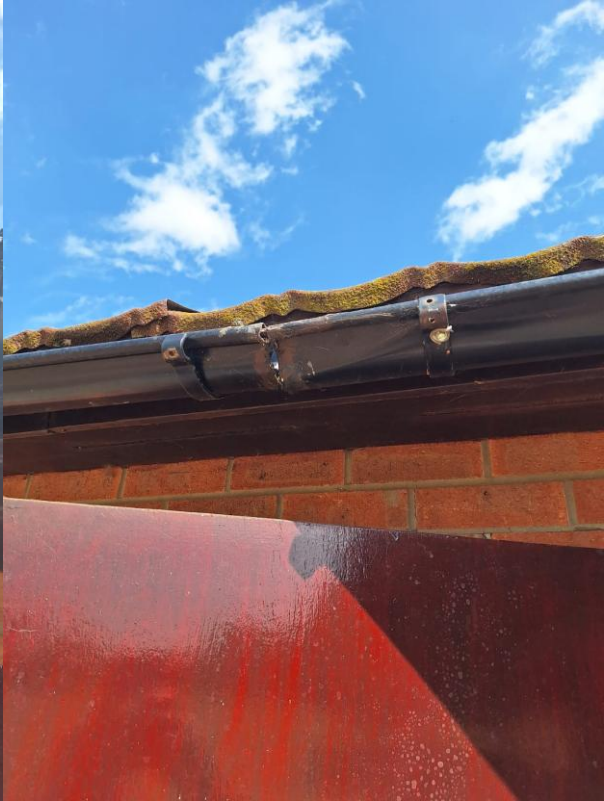
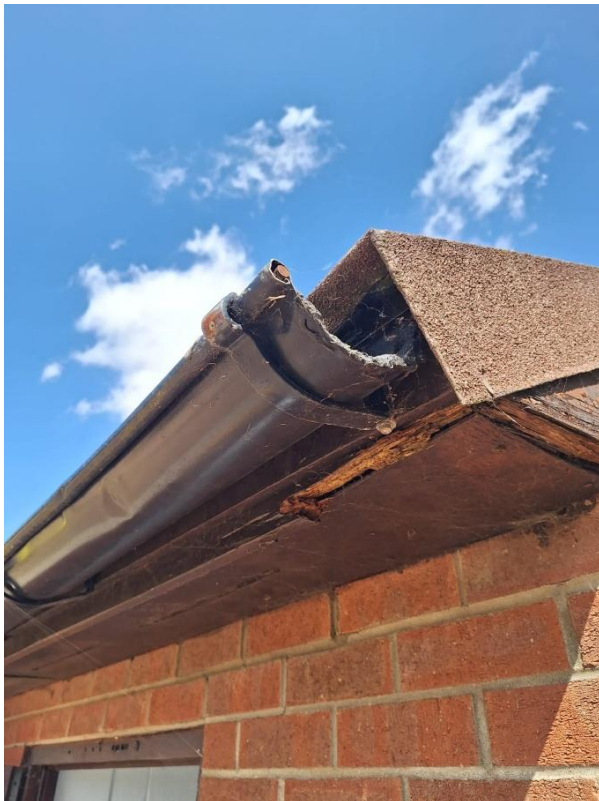
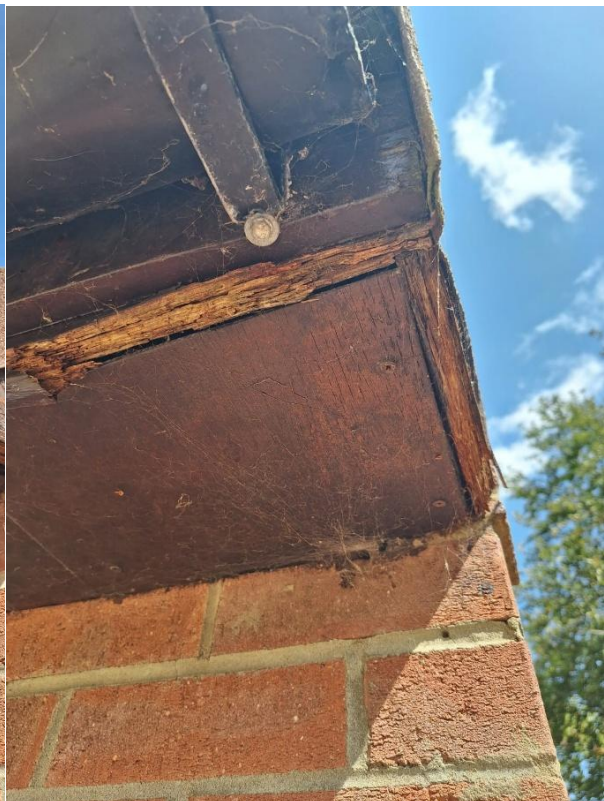
The Caretaker/Handyperson has reported that the metal guttering on the Potterhanworth Road pavilion is regularly being damaged. Whilst it is sometimes possible to straighten it out, it's not possible to close up the joints anymore, so water will leak through. The end cap has also disappeared, so water is now free to drain onto the soffit and fascia boards, which are starting to rot.

The guttering needs replacing, but consideration also needs to be given as to how it can be better protected to prevent the issue reoccurring. The rotting soffit and fascia boards also need to be repaired or replaced. Plastic guttering may be adequate, and far cheaper than steel guttering, although this will not be as resilient to further damage. Approximately 10 – 12 metres of guttering would be required.

- Take advice from an external contractor as to whether metal or plastic guttering is preferred.
- Repair/replace rotting soffit and fascia boards.
